A Review Paper on Slit Erosion

Anuj Sachar

Assistant Professor, Department of Civil Engineering, RIMT University, Mandi Gobindgarh, Punjab, India

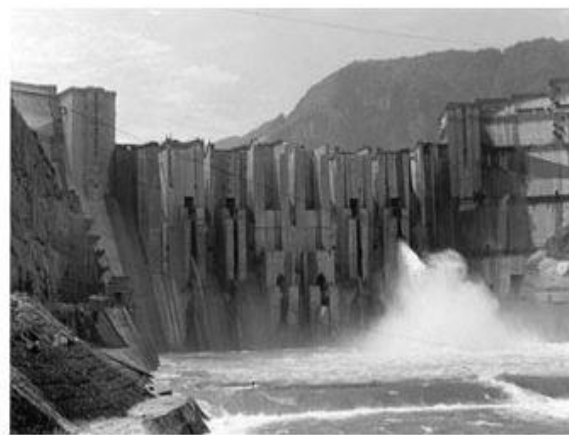
Figure 1: The above figure shows the Slit Bucket at Geheyan Dam in China

There have been reports of Slit Bucket being used in other nations, but it was not until the building of many dams in China that it became widespread. When the Chinese dam of Geheyan was still being constructed (26). The effluent flow is projected vertically using this mechanism, which consists of a rather sudden constriction of the spillway chute wall. This type of deflection does have an amount of air in the wastewater stream, and the region of pressure on the creek bed has a better geometric than a standard deflection. The constriction occurs at the discharge point of the overflow cascade, and it may be accomplished easily by diverting or expanding the walls, dependent on the results of the flow-induced effort research. Figure 1 shows the Slit Bucket at Geheyan Dam in China.

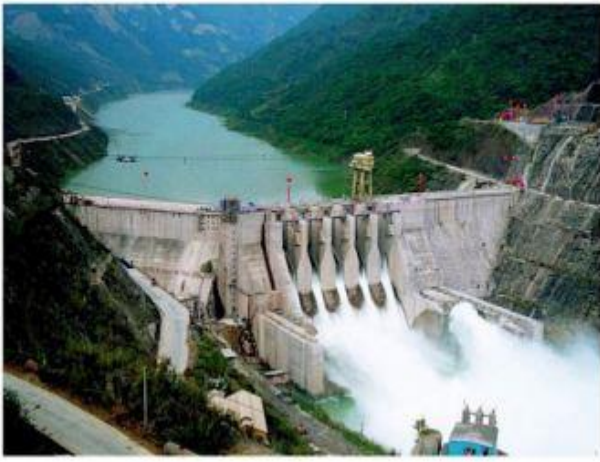
Figure 4: The above figure shows the Dachaoshan spillway

flowing fluid for the optimum normal amount, and a governed outfall with gates trying to measure 11.40 metres wide and 16.00 metres of water depth for the optimum reasonable amount. The dam is built on top of a diabase layer, with sedimentary rock forming the area that receives the jet's impact. Despite the current study's contribution, the issue remains. Figure 3 shows the shows the Scheme and typical sections of Flaring Pier and Figure 4 shows the shows the Dachaoshan spillway.
