# Repair And Rehabilitation of RCC Structures Using FRP

Abrar Ishaq

<sup>1</sup>M.Tech Scholar, Department of Civil Engineering, RIMT University, Mandi Gobindgarh, Punjab, India

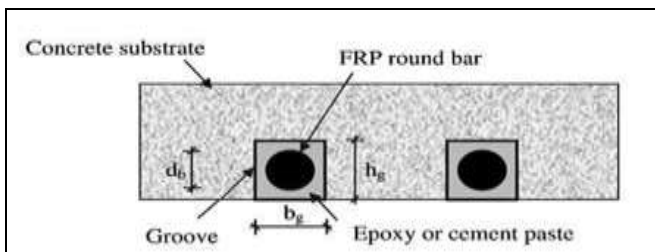
Figure 1: NSM system and nomenclature

When the strengthening processes were performed, the beams were in a hardened state .In order to begin installing the NSM FRP rods for the initial trial test beams, a series of grooves with specified and At the tension side of the beam sample, longitudinal holes with predetermined size were drilled into the concrete cover. Apparently, De Lorenzis used a chisel to carve these grooves (De Lorenzis, 2002). Based on the findings of bond tests with square grooves ( $b_g=h_g$ ) and the definition of  $k = b_g/ d_b$ , it was suggested that for round bars,  $k$  should have Smooth or lightly sandblasted bars should have a minimum value of 1.5, while deformed bars should have a minimum value of 2.0. The groove cross-section for the wrapped GFRP bars with  $d_b=13\text{mm}$  employed in this investigation would be  $b_g=20\text{mm}$  and  $h_g=20\text{mm}$  if  $k=1.5$ . (De Lorenzi set al., 2006).

The grooves were cut using a specialized concrete saw with a diamond blade, according to the Figure 1, recommended proportions 2 .The extra sides of grooves are removed once the appropriate sides have been cut off. To remove all dirt and debris, the concrete surface is made rough using a coarse sandpaper texture. Before inserting the FRP reinforcing bars, the glue is ready and placed into the groove. In line with the manufacturer's instructions, After being thoroughly mixed, the epoxy resin is sprayed over the grooved concrete surface.The epoxy resin is applied to the grooved concrete surface after being well mixed. After being thoroughly mixed, the epoxy resin is showered over the grooved concrete surface.The epoxy resin coating is subsequently applied to the GFRP rod. A constant, uniform pressure is applied while the epoxy is curing to ensure good contact between the epoxy, the concrete, and the GRFP rods shown in Figure 3. At room temperature, this procedure is performed. Once the epoxy resin in the groove had hardened after 24 hours, testing of the beams resumed.

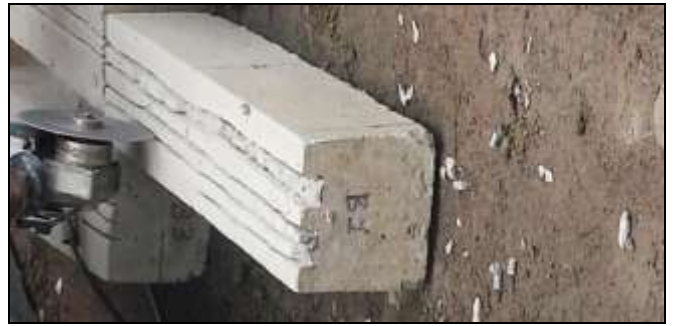
Figure 2: Groove preparation saw cut and chiseled

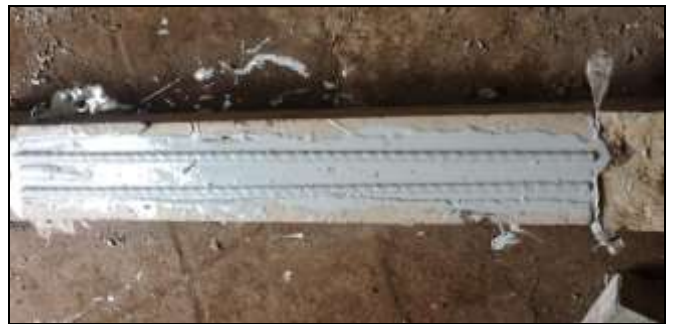
Figure 3: FRP rod inserted into epoxy resin at the bottom surface of the beam

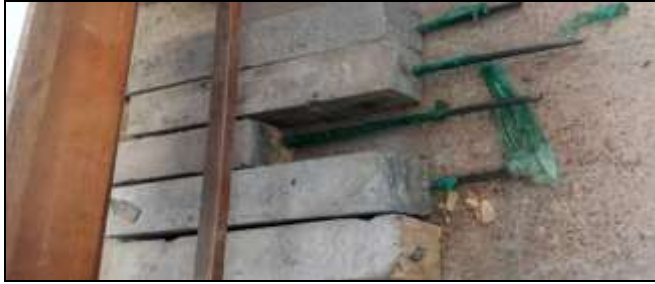
Figure 4: pipes casted in the bottom surface of the beam

As shown in below figure 4, pipes were inserted at the bottom surface of the second trial tests before casting the beams and were then pulled out to make room for the placing of FRP materials. Instead of incise, these pipes were used to compare, investigate, and demonstrate the impacts of that procedure, including tiny cracks and the wearing away of the concrete's top layer, which weakens the concrete. The pipes for beam C-1 were put below the stirrup, which is close to the bottom surface. The stirrup, which is situated between the bottom tension reinforcement, and the pipes were erected above it. for beams C-2 and C-3. By utilizing pipes in the structural components that are

vulnerable to damage, With the intention of providing room for additional repairing and rehabilitation processes, this was done in order to examine and compare the results with the first trial beams

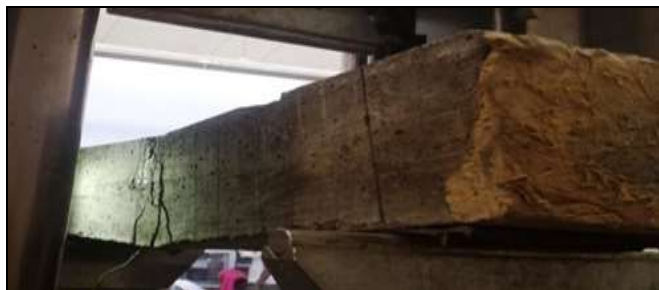
Figure 5: Failure Photo of Beam Bo-1

The observed failure modes are shown in Figure 5 to 9. Flexure with steel yielding was the main form of failure for beams Bo-1, B-1, B-2, and B-5. According to Figure.3, the loss of bond (debonding) between the GFRP rod and the concrete surface occurs when the tensile steel reinforcement yields, indicating that the beam has reached its maximum level of flexural strength. Shear failure, like in the case of B-3 and B-4 beams, was the second observed mode of failure. The tension zone insertion of GFRP rod increased the reinforcing ratio for these beams. which, as shown in Figure.2, was high, causing the concrete to be compressed before the tensile reinforcement gave way, which led to the RC element failing. Flexure failure was the mode of failure for the second trial's concrete beams, Co-1 to C-3, as shown in Figures.8 to 9.

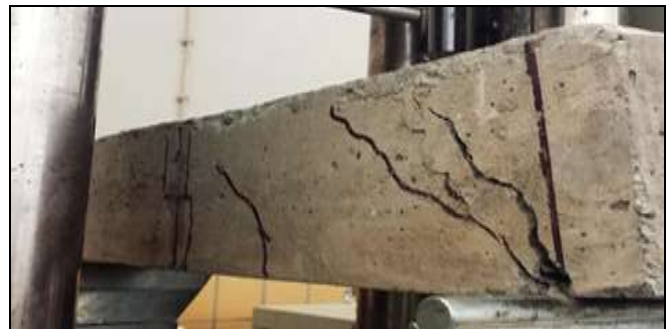
Figure 6: Failure Photo of Beam B-3

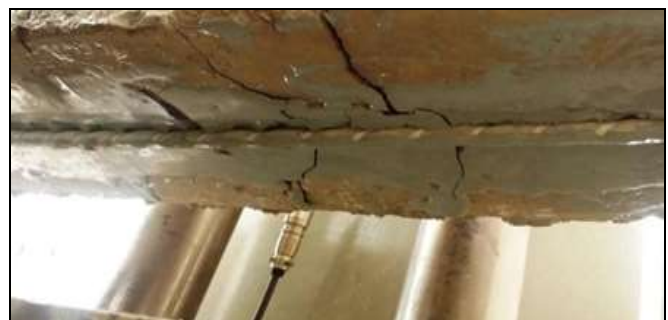
Figure 7: Debonding of GFRP rod shown on Photo of Beam B-5

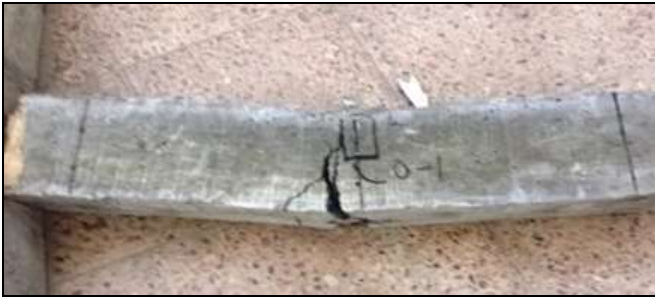
Figure 8: Failure Photo of Beam Co-1

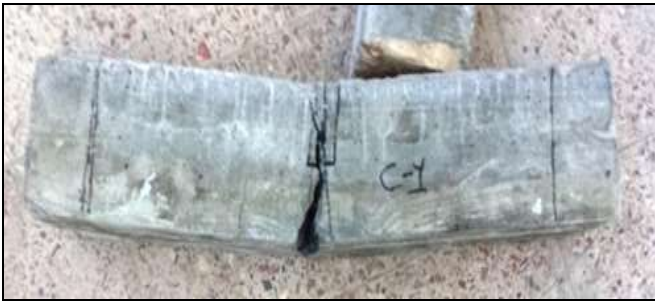
Figure 9: Failure Photo of Beam C-1
