Analysis On the Deteriorated Road Drainage System in the City of Srinagar

ABSTRACT- A study was conducted in the city of Srinagar India to find out the possible causes of poor drainage in the city. Preliminary surveys and various tests were conducted to find out the possible cause of the poor drains in the city. Every year during the monsoon season the drains get clogged and water level rises and the condition of roads become worse and commuters are unable to walk on them. In 2014 the drastic floods lashed out the whole city of Srinagar and caused social and economic problems. Every year the Government spends a huge amount of funds to repair the road infrastructure of the city but at the end of the year the condition of roads remains still deplorable. Study revealed that use of poor construction materials, improper engineering practices and corruption leads to all this. Solutions to curb this menace were forwarded at the end.

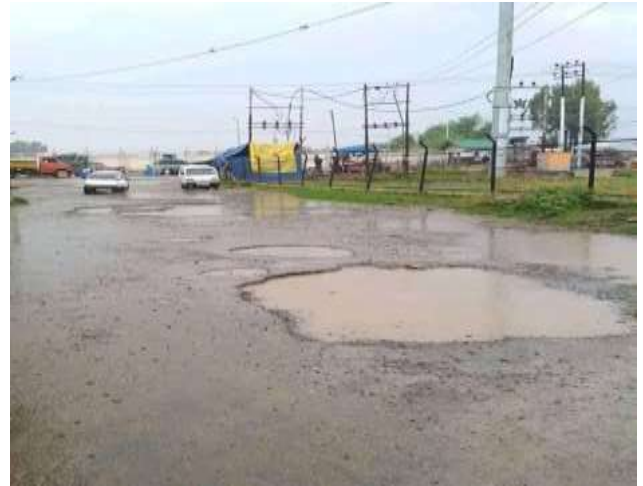
Figure 3: Batamaloo to Bemina

It is also an important route and is just around 2.5 kilometers from Lal Chowk, the city center (Figure 3). This specific road is in poor shape. It expresses the ugliness of administration and engineering. During the course of the investigation, this route was also investigated.

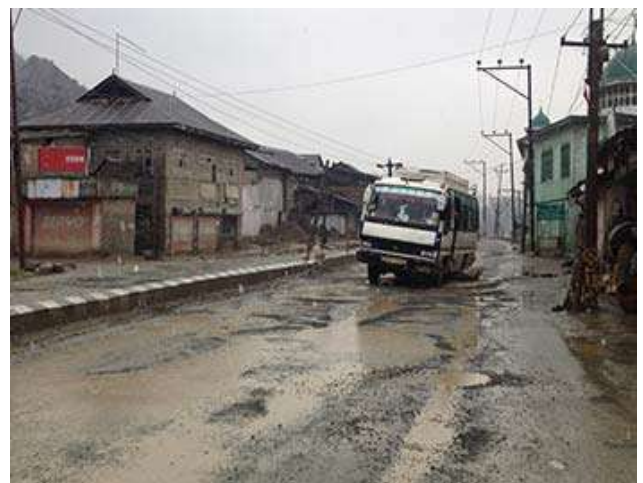
Figure 4: Pantha Chowk to Sonwar

This is also an important road section of Srinagar that acts as an alternate way for all the vehicles that come from the Southern part of the valley (Figure 4). It is around 5 Km in length and usually remains jammed as a number of important institutions lie on this road

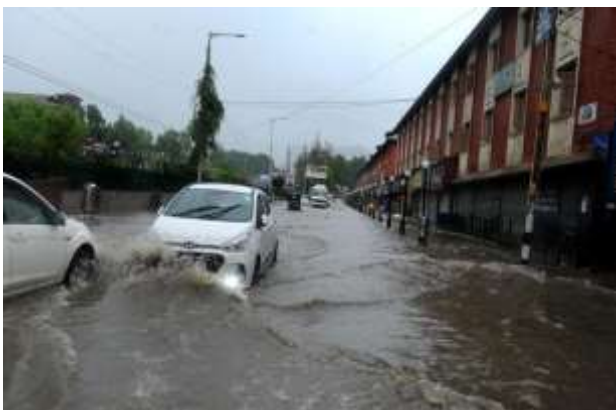
Figure 1: City Centre Lal Chowk

Lal Chowk to Karanagar is one of Srinagar's oldest roads, as well as the city's market center (Figure 1 & 2 respectively). The road has a single lane with a length of 2 kilometers and a width of 20 feet. A 0.75 km section was chosen for research purposes. The road had been repaired numerous times in the previous ten years, yet it still suffered from significant distress.

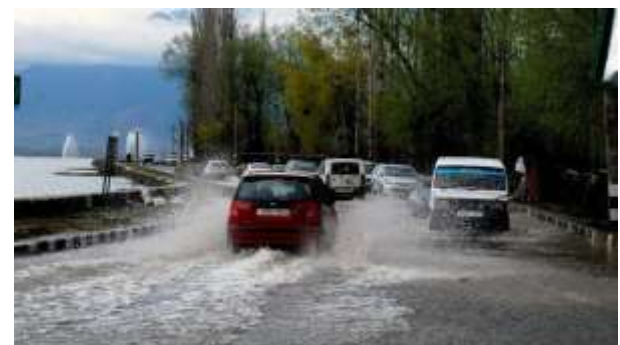
Figure 5: Foreshore Road Srinagar

Foreshore Road is one of the most prominent roads in Srinagar (Figure 5). The road's significance stems from the fact that it runs entirely along the shores of Dal Lake. The route begins in Hazratbal and finishes at Nishat. It is around 5 kilometers long and suffers from water logging during the wet season. For research purposes, a length of around 1 km was chosen.
