# Radiographic Evaluation of Bioglass and Polymethylmethacrylate for Long Bone Fracture Repair in Dogs

**Key words:** Bioglass, Dogs, Locking compression plating, Long bone fracture, PMMA bone cement.

*Ind J Vet Sci and Biotech* (2024); 10.48165/ijvsbt.20.5.27

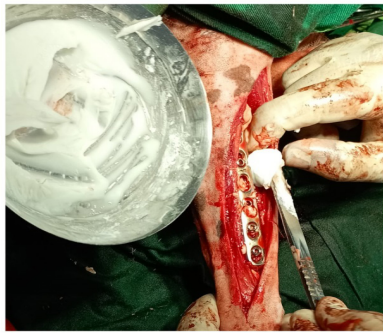
**Fig. 2:** Application of PMMA at fracture gap using sterile spatula in case no. 2 of group II

The Group I dogs were treated with Locking Compression Plate with bioglass putty as filling agent at interfragmentary spaces (Fig. 1), while those in Group II were treated with Locking Compression Plate with PMMA (Polymethyl methacrylate) as filling agent at interfragmentary spaces (Fig. 2, 3). Two radiographs, viz. cranio-caudal view and medio-lateral view were taken preoperatively to evaluate status of bone fracture, number of fracture fragments, direction of fracture fragments, diameter of medullary cavity, length of fracture fragments to predict the size of bone plate and screw (Langley-Hobbs, 2003). The radiographic evaluation was again carried out on day 15<sup>th</sup>, 30<sup>th</sup>, and 60<sup>th</sup> post-operatively to access bone healing in all cases. The bone formation score (BFS) and the bone union score (BUS) in dogs of group I and group II were assessed according to the system given by Lane and Sandhu (1987). The Mann-Whitney test was used for statistical data analysis.

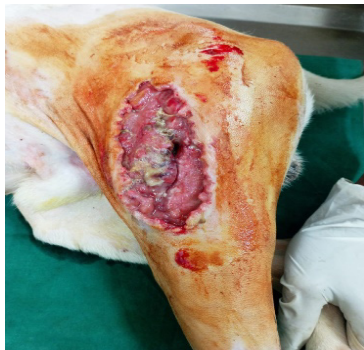
**Fig. 3:** Wound dehiscence noted in case no.6 of group II due to exothermic reaction of PMMA bone cement

In one of the cases of group II (case no.6), the wound dehiscence due to soft tissue, muscle and bone necrosis

was noted due to the exothermic reaction exhibited by PMMA during curing (Fig. 5). The correction was done by debridement and resection of the affected part. On the contrary, bioglass does not induce an inflammatory response in body, and it gets resorbed completely in 6 months (Moimas *et al.*, 2006). Adverse reactions with PMMA bone cements reported in humans include transitory fall in blood pressure, elevated serum gamma-glutamyl transpeptidase, thrombophlebitis, superficial or deep wound infections, short term cardiac conduction irregularities and heterotrophic new bone formation (Ranjan *et al.*, 2015).

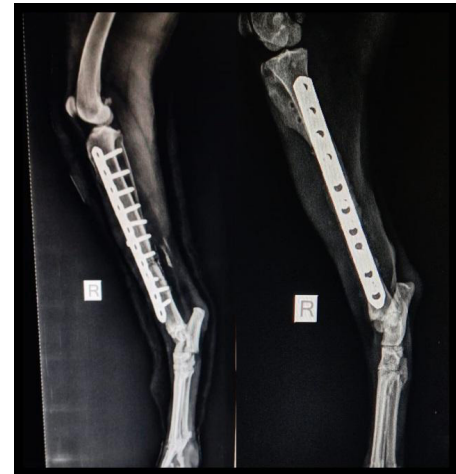
Soft callus formation at fracture site at right tibia-fibula in cranio-caudal and lateral view on 30<sup>th</sup> day after surgery in case no.2 of group I, with BFS:3 and BUS:4.

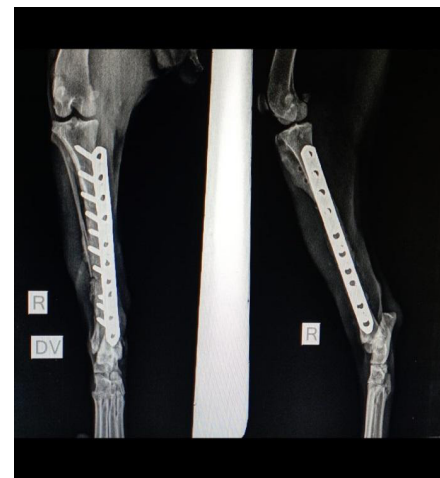
**Fig. 4:** Radiographic evaluation of bone healing in case no.2 of group I

Bridging callus formation at fracture site at right tibia-fibula in cranio-caudal and lateral view on 60<sup>th</sup> day after surgery in case no.2 of group I, with BFS:4 and BUS:4.

details of bone formation score (BFS) and the bone union score (BUS) in dogs of group I and group II are given in Table 1. The data revealed that the bone formation and bone union scores were significantly improved at 15<sup>th</sup>, 30<sup>th</sup>, and 60<sup>th</sup> day interval of observations in both the groups (Fig. 4, 5).

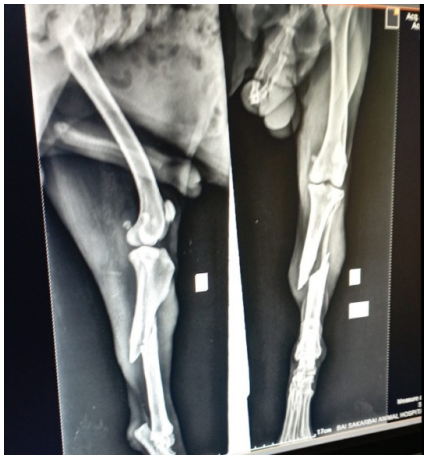
Radiograph showing oblique fracture at mid shaft at left tibia-fibula in cranio-caudal and lateral view case no.3 of group II

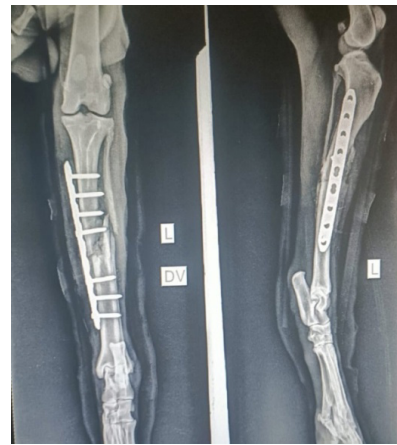
Bridging callus formation at fracture site at left tibia-fibula in cranio-caudal and lateral view on 15<sup>th</sup> day after surgery in case no.3 of group II, with BFS:2 and BUS:2.

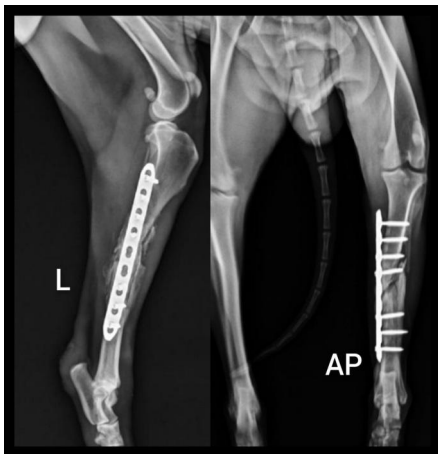
Soft bridging callus formation at fracture site at left tibia-fibula in cranio-caudal and lateral view on 30<sup>th</sup> day after surgery in case no.3 of group II, with BFS:3 and BUS:4.
